# Spray-Applied Protective Coating for Process Equipment Operating at Elevated Temperatures

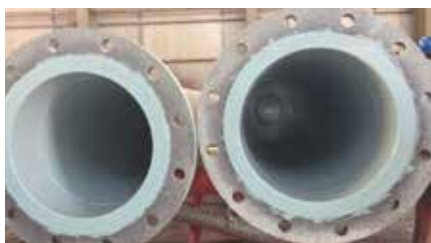
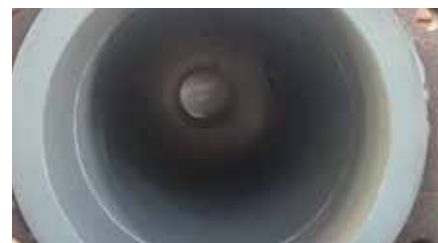
The light colours of Belzona 1523 allow easy visual inspection in vessels.
